# Long-Term Performance of Corrosion Inhibitors Used in Repair of Reinforced Concrete Bridge Components

PUBLICATION NO. FHWA-RD-01-097

JULY 2003

9. Performing Organization Name and Address CONCORR, Inc. 44633 Guilford Drive, Suite 101 Ashburn, VA 22011		11. Contract or Grant No. DTFH61-94-C-00054

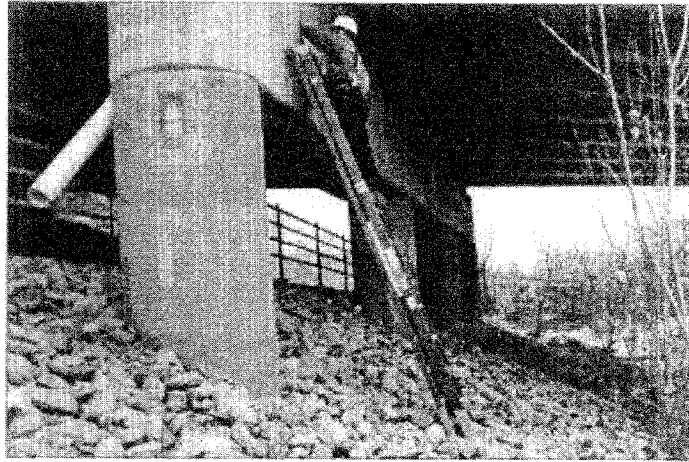
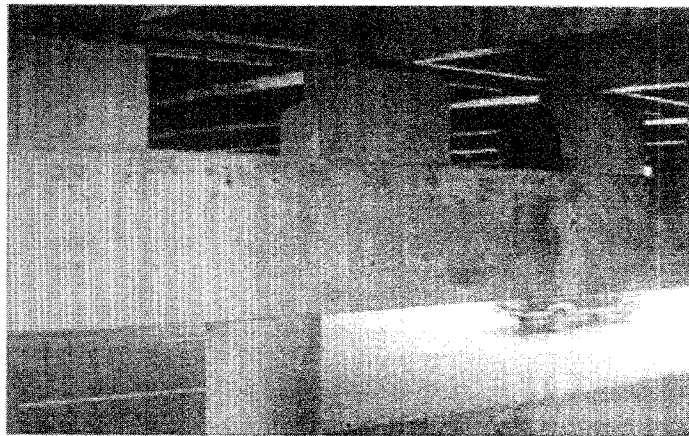
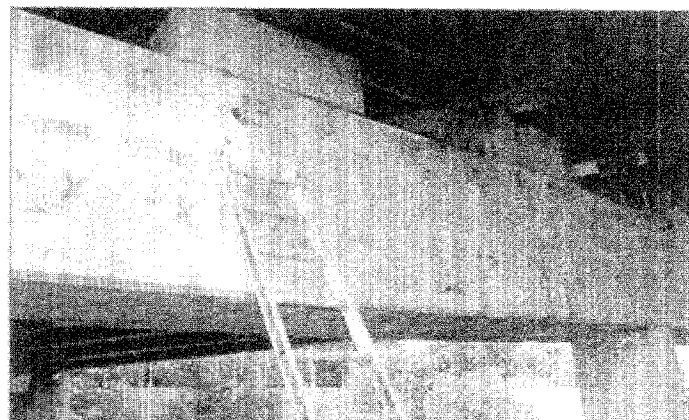
**Figure 2-2. Views of test sections on: (a) south pier (control), (b) middle pier (Cortec 2000), and (c) north pier (DCI).**

Visual surveys were conducted during all three visits. In October 1994, approximately 2 years after the repair of the piers, the west section of the south face of all three pier caps appeared sound and no spalls were observed. The patched areas, particularly those with inhibitor treatments, were severely cracked. The observed cracking pattern was mud-flat cracking, typical of drying shrinkage cracks. During the second and third visits (May 1997, and June 1998, respectively), the drying shrinkage cracks appeared to be about the same. However, minor spalling was observed in the three piers.

All patched areas, particularly those treated with the inhibitor, had suffered shrinkage cracking. The cause of shrinkage cracking was not determined in this study. Immediately after the installation of the repairs, hollow-sounding areas were detected. The formation of hollow-sounding areas was attributed to lack of bonding between the patch material and the original concrete. Generally, bond failure occurs soon after the installation of new concrete and does not continue to occur with time. The size and number of hollow-sounding areas in patches continued to increase with time. This suggests that a process other than bond failure was responsible for the increase in hollow-sounding areas. Some cores extracted from patches in the control pier and the treated piers exhibited ongoing corrosion and consequent formation of delamination.

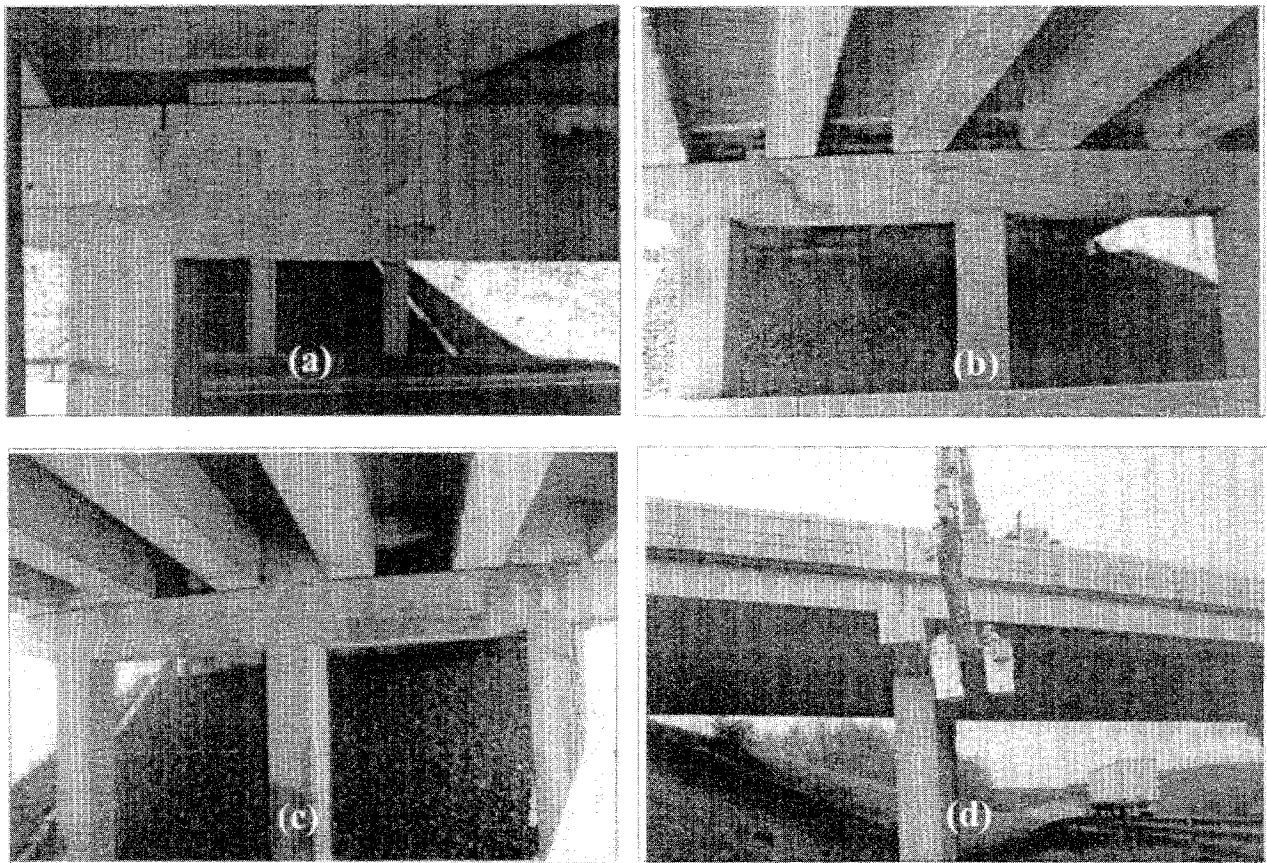
**Figure 3-2. General views of piers:**

During the first visit, the concrete surface of the three pier caps did not have spalls. All patched areas on the three pier caps were cracked. Detailed mapping of the cracks was not performed. Cracks generally occurred along patch perimeters and the crack pattern within patched areas was typical of drying shrinkage cracking. Cracking was not observed in the original concrete areas. Visual observations of the three piers during the second visit did not show much change compared to the first evaluation. During the third visit, approximately 2.5 m of new cracks were documented in the patch areas of pier 3 (treated with Cortec 2000). These cracks did not appear to be caused by drying shrinkage. Outside the survey area of pier 3, corrosion products were visible in the original concrete. The shrinkage cracks on the other two piers remained the same. Spalls were not visible on any of the three pier caps.

During the first visit, hollow-sounding areas were detected in the patched areas and original concrete of pier 2 (treated with DCI Postrite). The hollow-sounding areas were 0.372 m<sup>2</sup> and 0.093 m<sup>2</sup> for the patched and original concrete, respectively. During the third visit, 0.093 m<sup>2</sup> of hollow-sounding area in the original concrete was found on pier 1 (control). The hollow-sounding area in the original concrete on pier 2 remained the same. However, the hollow-sounding area in the patched section on pier 2 was found to be somewhat less than that documented during the first visit. This discrepancy resulted from a confusion of the grids marked on the surface of the test area. Drawings of the delaminations suggest that the delaminations increased with time. No hollow-sounding sections were identified on pier 3 (treated with Cortec 2000). Table 3-1 summarizes the delamination survey results.
